CFR ENDLAP ASSEMBLY GAUGE

TECHNICAL BULLETIN
Vol. 2, No. 6
APRIL, 2004

CFR-42 Endlap Assembly Gauge

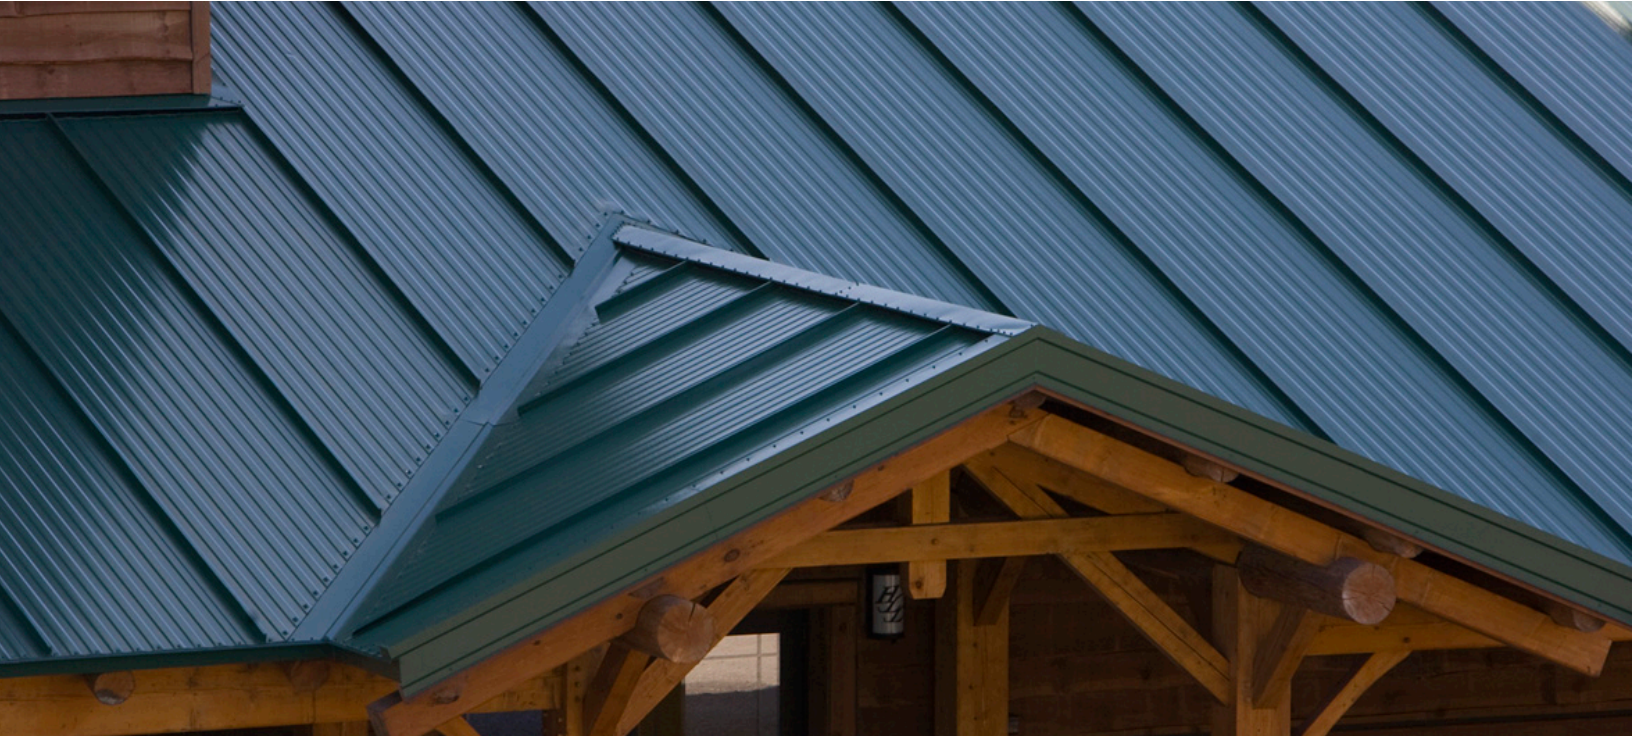
One of the most commonly observed erection errors on CFR jobs has been the incorrect placement of the sealants and fasteners at the panel end lap. This is one of the most critical details of any metal roof system especially in low slope applications. An assembly gauge has been developed to simplify the location and placement of the sealant and fasteners. This gauge has now been incorporated into the installation details of the CFR42 panel.
